# Manhole Inspection Summary

Manhole # S15A\_\_018MH

Insp Date: **11/28/07 1:47 PM**

**Location** Address: **2649 RAYNOR**

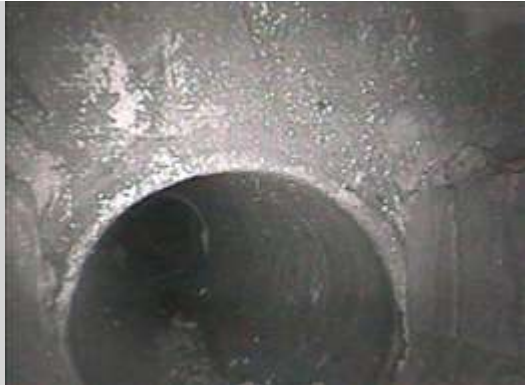
12 O'Clock Outflow

8 in. Circular Gravity Sewer  
Pipe Out @ 12 O'Clock

Pipe Material: **Clay** ☐ Pipe Lined

Invert Depth: **13.38** (ft.) Flow Characteristics: **None**

Deposits: ☒ None ☐ Mud ☐ Sludge ☐ Debris ☐ Grease

Infiltration: **None** Pipe Seal Cond: **Sound**

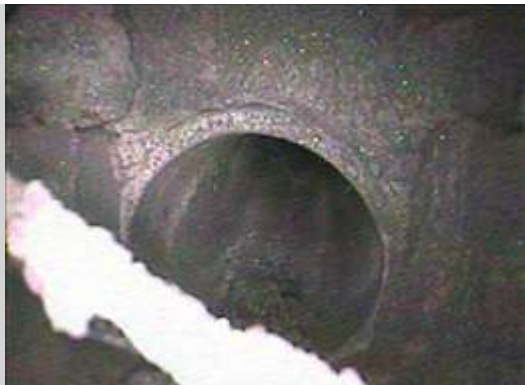
9 O'Clock Inflow

6 in. Circular Gravity Sewer  
Pipe In @ 9 O'Clock

Pipe Material: **Clay** ☐ Pipe Lined

Invert Depth: **13.03** (ft.) Flow Characteristics: **None**

Deposits: ☒ None ☐ Mud ☐ Sludge ☐ Debris ☐ Grease

Infiltration: **None** Pipe Seal Cond: **Sound**
